Redranger/Nolathane

Brakes Don't Stop The Car!

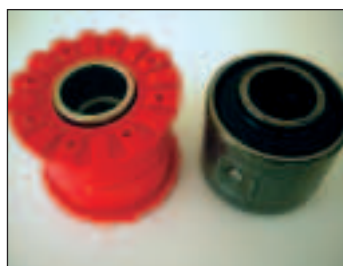
Nolathane voided design compared to Subaru hydraulic front lower control arm inner rear bush.

Hydraulic or fluid filled bushes are no longer found in only prestige German marques. Commodore, Falcon, Magna & Subaru are all running hydraulic bushes in their front end. In an effort to absorb much of this energy without compromising vehicle handling or NVH (Noise, Vibration & Harshness) original rubber bush technology is moving to these larger hydraulic bushes. Unfortunately our road conditions are such that we do not obtain the same life out of the hydraulic bushes as we would like. This is due to these road conditions combined with aggressive driving or regular activation of ABS or clipping a round-a-bout / kerb. We then find the hydraulic fluid is being pumped out of these bushes.

The Nolathane team are continuously expanding the range of bushes to replace these failed hydraulic bushes. The innovative designs ensure that there is no noticeable increase in NVH and in all cases steering response will also be improved. The Nolathane bushes will not tend to pump or deform as much under braking therefore providing a more confident brake pedal feel and less squirming of the vehicle.

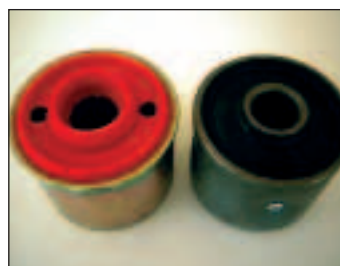
Nolathane voided design compared to Mitsubishi hydraulic front lower control arm inner rear bush.
