## Brakes Don't Stop The Car!

**That's right! The brakes only retard the wheel rotation, so what stops the car?**

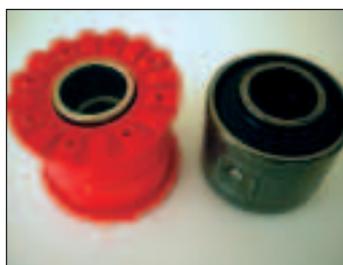
*Nolathane voided design compared to Subaru hydraulic front lower control arm inner rear bush.*

The Nolathane team are continuously expanding the range of bushes to replace these failed hydraulic bushes. The innovative designs ensure that there is no noticeable increase in NVH and in all cases steering response will also be improved. The Nolathane bushes will not tend to pump or deform as much under braking therefore providing a more confident brake pedal feel and less squirming of the vehicle.

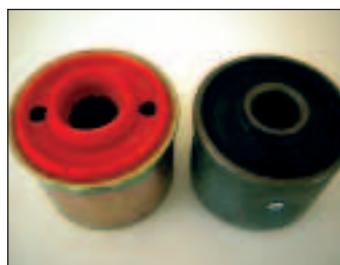
*Nolathane voided design compared to Mitsubishi hydraulic front lower control arm inner rear bush.*
