Nolathane Part No's. 42790 & 42792 **Universal Ball Type Sway Bar Links**

These universal links are:

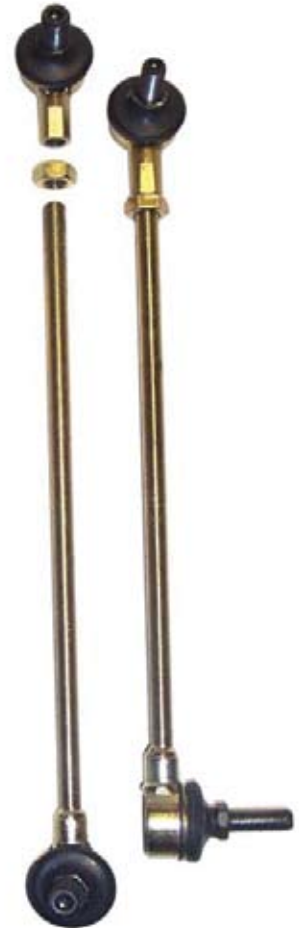
42790 - PAIR 10mm thread ball fitting at each end - 320mm long

42792 - PAIR 12mm thread ball fitting at each end - 320mm long

The new **Nolathane** universal ball links are extra long at 320mm. This enables them to be fitted to vehicles such as Holden Adventra, Cross6 & Cross8 Crewman or four wheel drives which have very long original links. These links are available in two part numbers. Both are 320mm long with 42790 having 10mm threaded ball fittings at each end to suit most passenger car applications and 42792 with 12mm for 4WD's.

The links use 10mm heavy duty threaded rod which is thicker than most original links and the **Nolathane** units are made from M10 grade, class 4.6 steel which is also stronger.
