Nolathane Part No. 45466 & 45503

Holden Adventra, Crewman Cross6 & Cross8
Front Lower Control Arm Bushes

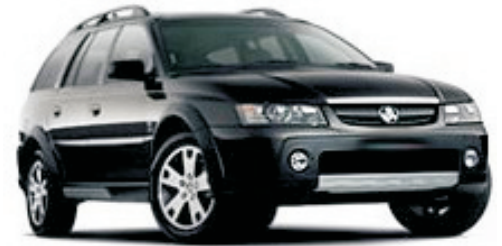
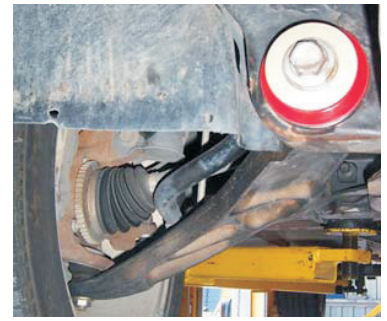
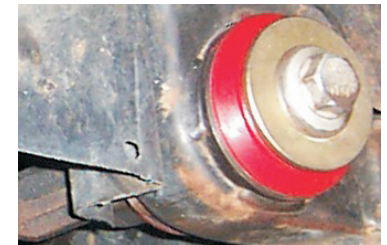
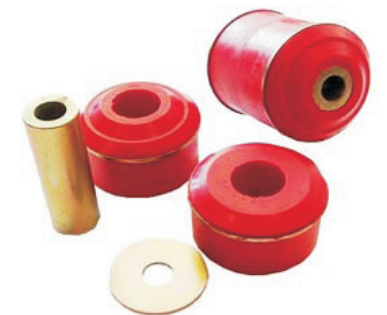
The Holden Adventra & Cross8 Utes are the first Commodore derived models to move away from the traditional radius rod type front suspension. The front lower control arm on these AWD models uses a one piece "A" arm that has a rubber bush directly inboard of the wheel and a very large hydraulic (fluid filled) bush at the front of the arm, located in the crossmember below the radiator.

This front bush is large at 80mm in diameter and almost 100mm long & contains a great deal of hydraulic fluid. When new, this design provides a good compromise between ride and handling, however loss of the fluid as a result of poor road conditions or clipping a kerb is common even at very low mileage. The Crewman Cross8 weighs almost 2 tonnes unladen and if these hydraulic bushes are not in optimum condition the steering response and handling suffers greatly, causing the vehicle to seem unresponsive & heavy.

The solution is to replace both lower inner control arm bushes with **Nolathane**, especially the front bushes. The new Nolathane kits are **45466** front and **45503** rear and whilst they contain no fluid they are made from the softest **Nolathane** formulation ensuring no compromise in ride with significant improvement in handling and steering response. They genuinely transform the handling and steering character of these AWD models. The original front bush is steel cased and pressed into the front crossmember; therefore it is necessary to cut out the original. The replacement **Nolathane** kit is very easy to install. They are a simple two piece urethane design with washers cast into the flange faces to handle the load and a large front washer to give a progressive loading onto the tapered nose of the bush.

Roll the vehicle at low speed (3kph) and apply the brakes firmly. Have an observer safely watch the front wheel movement rearward during braking and (more easy to observe) forward during release of the brakes. Sudden wheel movement of 10mm or more is indicative of failure. The hydraulic fluid is water soluble so it is likely that any leakage will have washed off, so looking for leaking fluid is not the best diagnosis. (Refer **Nolathane Update 0503 – Hydraulic Suspension Bushes for more information.**)
