# INSTALLATION GUIDE

## Rear Camber Correction Kit

Mitsubishi Pajero NM-NW  
- lower inner bushing.

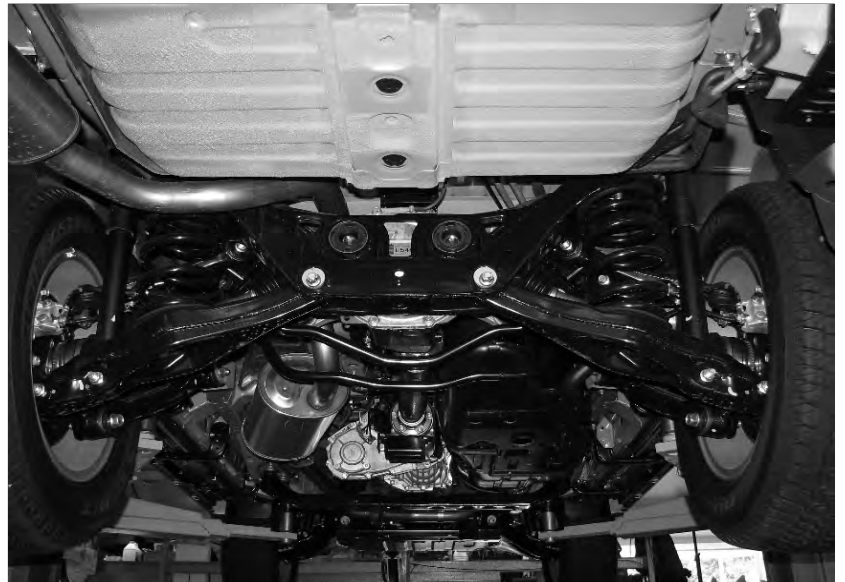
### View from rear of vehicle.

Objective - push lower hub outwards with supplied offset bushing.

LH Bushing

RH Bushing

1. Carry out an initial wheel alignment to confirm rear camber settings.
2. Raise the vehicle evenly and safely support.
3. Remove the rear wheels.
4. Support the lower arm and un-bolt the lower shock mount. Proceed to lower the arm, then un-bolt the inner and outer points.
5. Press out the Inner bushings. Prior to pressing in the supplied Offset bushing, refer image below.
6. Once bushing is installed, grease the ID and face and insert the supplied tube.
7. Re-fit lower arm to vehicle. Before carrying out a W/A, it is recommended to drive the vehicle on and off the hoist in workshop to settle the Suspension.
8. Carry out W/A and fine tune rear camber and toe with the OE eccentrics.
