## Redranger/Nolathane

### An Off-the-shelf Solution for Ball Type Sway-bar links

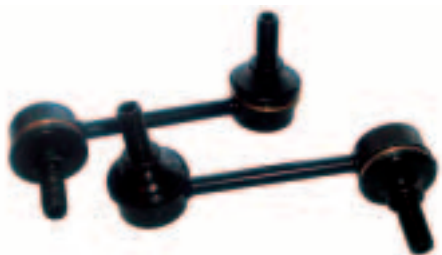
*Example of Nolathane left and right handed specific fit link kit for late model Falcons.*

Many newer vehicles now use sway-bar links with ball fittings at both ends. Most vary in length and some are left or right handed, with the ball fittings at each end not always parallel. It is now becoming increasingly

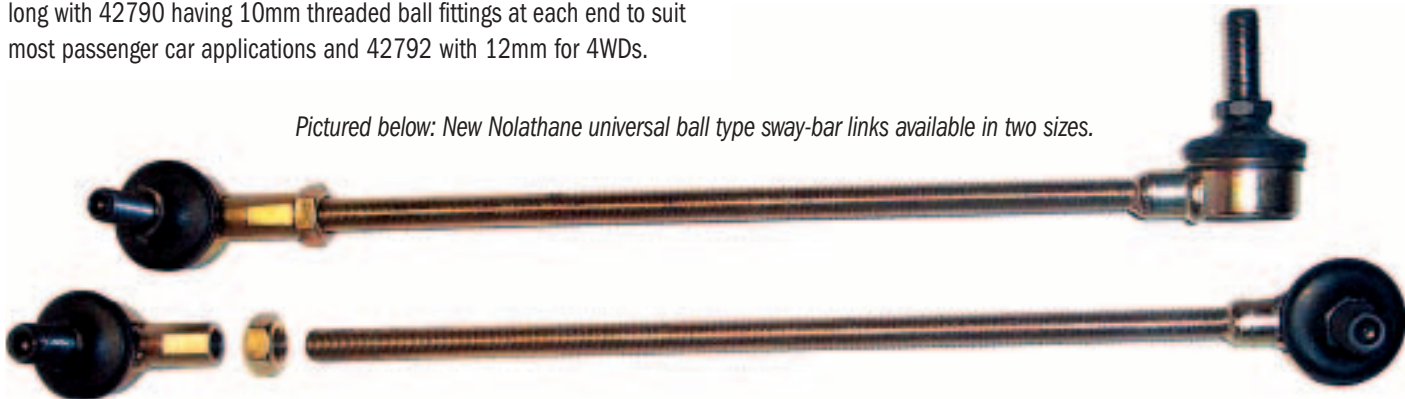
*Pictured below: New Nolathane universal ball type sway-bar links available in two sizes.*

The links use 10mm heavy duty threaded rod which is thicker than most original links and the Nolathane units are made from M10 grade, class 4.6 steel which is also stronger.

The new Nolathane universal ball links are extra long at 320mm. This enables them to be fitted to vehicles such as Holden Adventra, Cross6 and Cross8 Crewman or four wheel drives which have very long original links. These links are available in two part numbers. Both are 320mm long with 42790 having 10mm threaded ball fittings at each end to suit most passenger car applications and 42792 with 12mm for 4WDs.
