Redranger/Nolathane

An Off-the-shelf Solution for Ball Type Sway-bar links

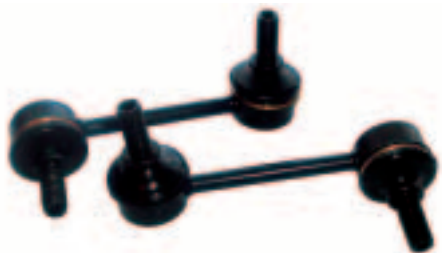
Example of Nolathane left and right handed specific fit link kit for late model Falcons.

Many newer vehicles now use sway-bar links with ball fittings at both ends. Most vary in length and some are left or right handed, with the ball fittings at each end not always parallel. It is now becoming increasingly

difficult for our distributors to ensure they have all of the possible sizes and shapes of these links in stock when needed.
